Crystal defect evaluation of silicon carbide (SiC) using an electron microscope

Toshiyuki Isshiki

Kyoto Institute of Technology,
Department of Electrical Engineering and Electronics,
Professor

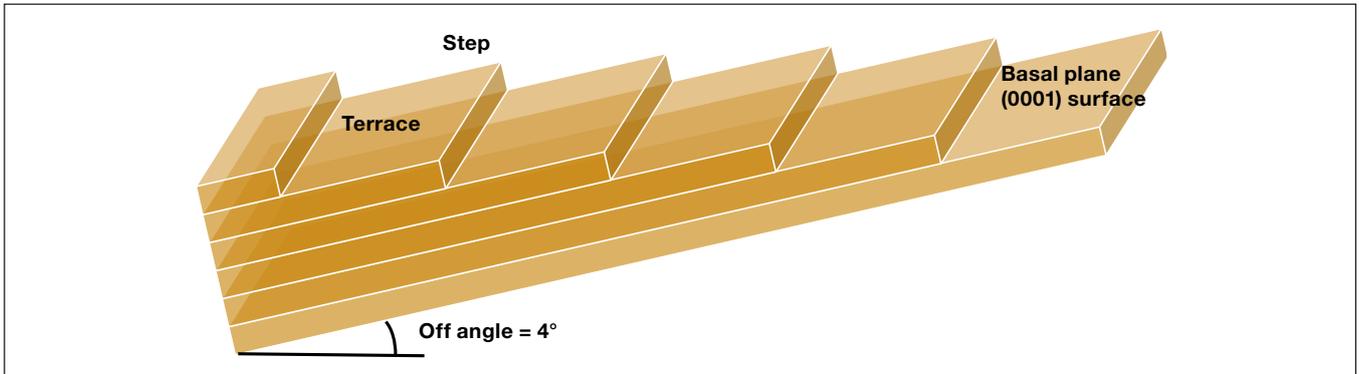
Fig. 1 Schematic diagram of the surface structure of SiC epitaxial crystals

As shown in Fig. 1, SiC devices are prepared by epitaxial growth of the basal plane, at an inclination solely in the angle termed the "off angle". Basal planes laid down sequentially on the epitaxial crystal surface are termed "terraces", and steps are formed at the ends of the terraces. Crystal growth progresses by adherence of atoms to the ends of these steps, so that the steps advance. As crystal growth progresses, the orientation of the wafer surface should ideally be consistent, and steps should be formed at approximately equal intervals⁵⁾. This mechanism is termed "step-flow growth". We suspected that, if there are crystal defects on the crystal surface, there may be disorders of step flow in the vicinity, leading to changes in step morphology, and we therefore investigated the microscopic morphology of epitaxial crystal surfaces. The samples used in this research were commercially available SiC epitaxial wafers with off angles of 4°, minimum step heights of 1 nm, and terrace widths of 14 nm. In order to evaluate the morphologies of steps of this type, there is a need for observation techniques that have high (nanometer-order) resolution in both the horizontal and vertical directions. SEM is in wide use for evaluating the structures of sample

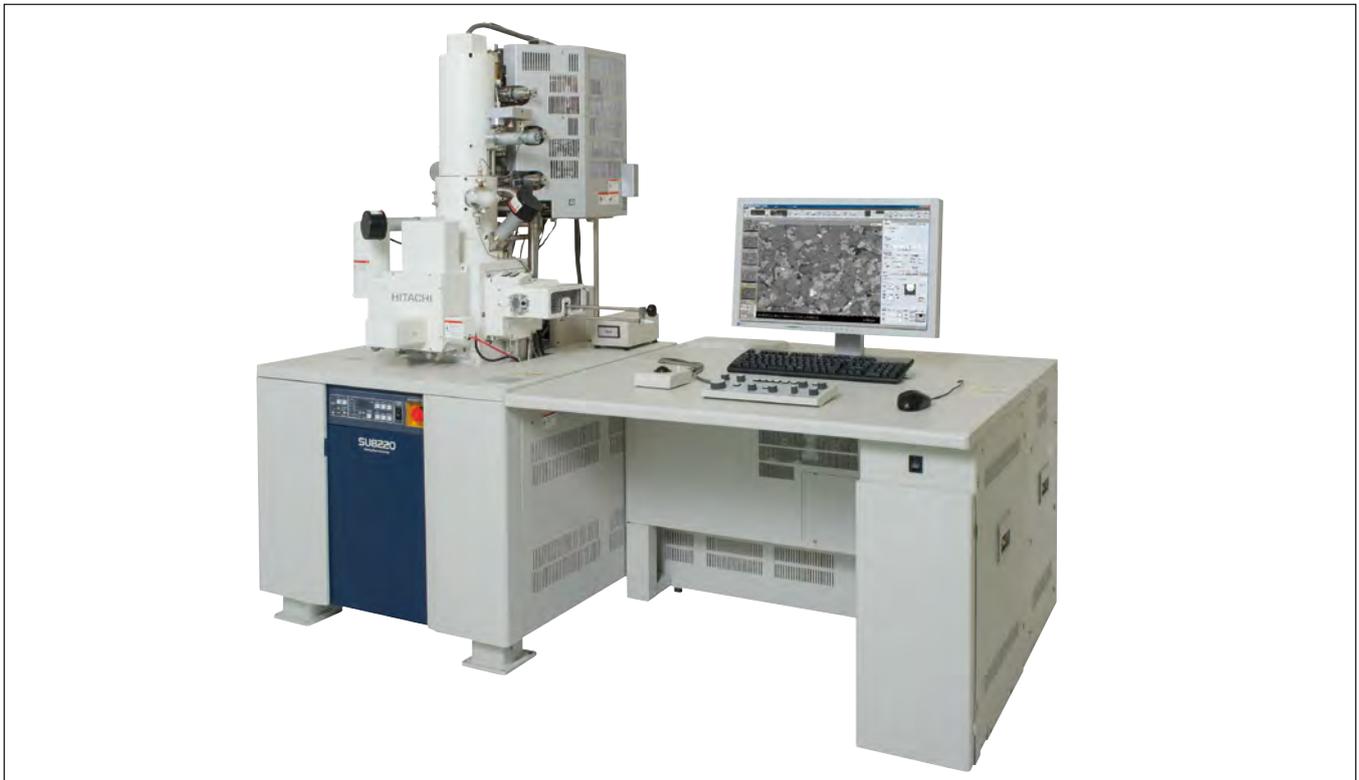
Fig. 2 External view of SU8220

In this research, evaluation was tried using an SU8220 (Hitachi High-Technologies Corporation; Fig. 2), with the irradiation energy being 500 eV. In addition, in order to detect electrons discharged from areas as close as possible to the sample surface, evaluation was carried out using a detector that detects low-emission-angle backscattered electrons.

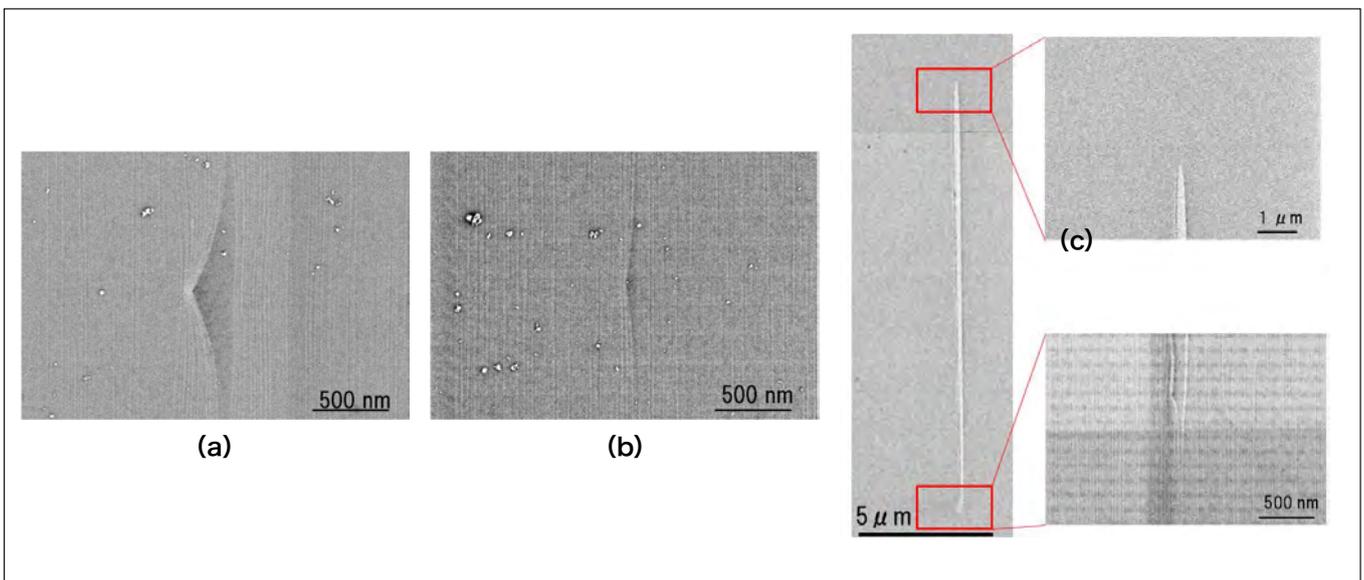
Fig. 3 SiC epitaxial wafer surface defects
(a) Surface defects with triangular terraces; terrace width: 270 nm
(b) Surface defects with triangular terraces; terrace width: 90 nm
(c) Surface defects with parallel terraces

The results of SEM evaluation of numerous visual fields of the wafer surface confirmed that the growth steps were aligned on the SiC epitaxial wafer surface at approximately equal intervals. In addition, it was shown that there are surface defects with unique step morphology, and that these are of two types, with one having triangular terraces, and the other having wide, parallel terraces. SEM images of the surface defects are shown in Fig. 3, with the step flow progressing from left to right. It can be seen in these SEM images that numerous fine, linear structures extend from above to below, and these are arranged at approximately regular intervals. They represent the growth steps, with the minimum inter-step interval being 10 to 20 nm. It is therefore considered that steps corresponding to a simple lattice can be observed by SEM. In Fig. 3 (a) and (b), the steps are inflected close to the centers of the images, and form triangular terraces. The length of each terrace is approximately 2 μm , in alignment with the step, and the terrace widths are 270 and 80 nm, respectively, in Fig.3 (a) and (b). Figure 3 (c) is an SEM image of the surface defects of parallel terrace morphology. A terrace 100 nm wide is formed here, crossing a region that is approximately 15 μm wide and aligned with the terrace. The upper end of the terrace converges, with approximate left-right symmetry, whereas at the lower end the steps at the downstream side of the step flow form a straight line, but the steps at the upstream side bend and converge.

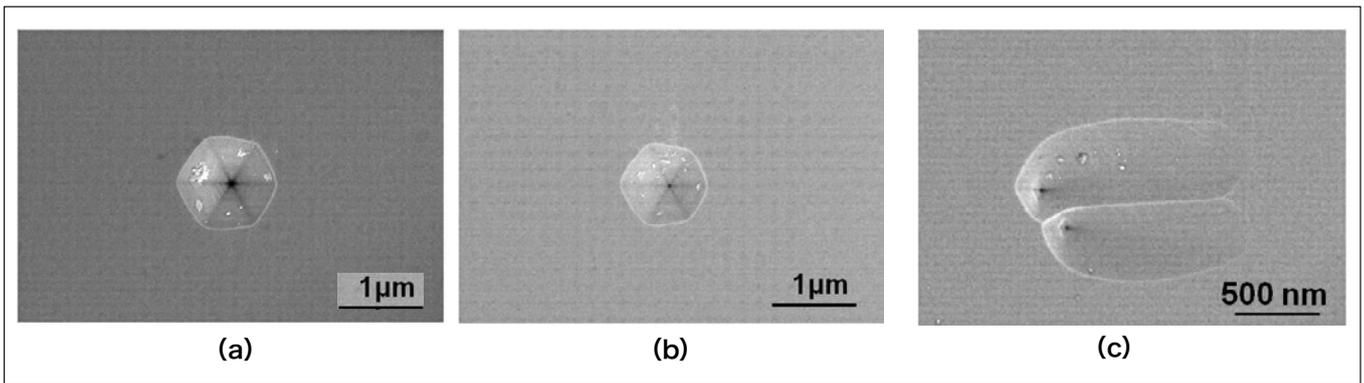
Fig. 4 Morphology of surface defects after potassium hydroxide etching
 (a) Surface defects with triangular terraces; terrace width: 270 nm
 (b) Surface defects with triangular terraces; terrace width: 90 nm
 (c) Surface defects with parallel terraces

Next, in order to confirm whether there is a relationship between surface defects and dislocations, the SiC wafer was subjected to etching treatment using high-temperature, molten potassium hydroxide. Molten potassium hydroxide etches in priority at loci where dislocations can be seen on the SiC wafer surface, and it forms pits, with the pit morphology varying according to the type of dislocation⁷⁾. Figure 4 shows SEM images of the surface after etching, these being the results of evaluation of the same loci as those shown in Fig.3. In Fig. 4 (a) and (b), hexagonal etching pits were formed where the steps were inflected in Fig. 3 (a) and (b). On the basis of pit morphology, it is considered that triangular surface defects are due to threading dislocations. Whereas the step flow progresses in a normal manner at the sites of divergence due to dislocations, at threading dislocations the step progression is prevented in a localized manner, and it is considered that triangular terraces are formed as a result of subsequent steps gaining ground at these loci. Figure 4 (c) shows the morphology after etching of the surface defect areas that have parallel terraces. When the same loci as in Fig. 3 (c) were evaluated, the steps were inflected at the upstream sides of the step flow at the lower ends of the terraces, and at these loci it was shown that two pseudoelliptical etching pits due to basal plane dislocations were superimposed. No other etching pits were found at neighboring areas that included defects. On the basis of these findings, it is considered that crystal defects appearing on the wafer surface are closely linked to surface morphology, and that crystal defects influence step-flow growth.

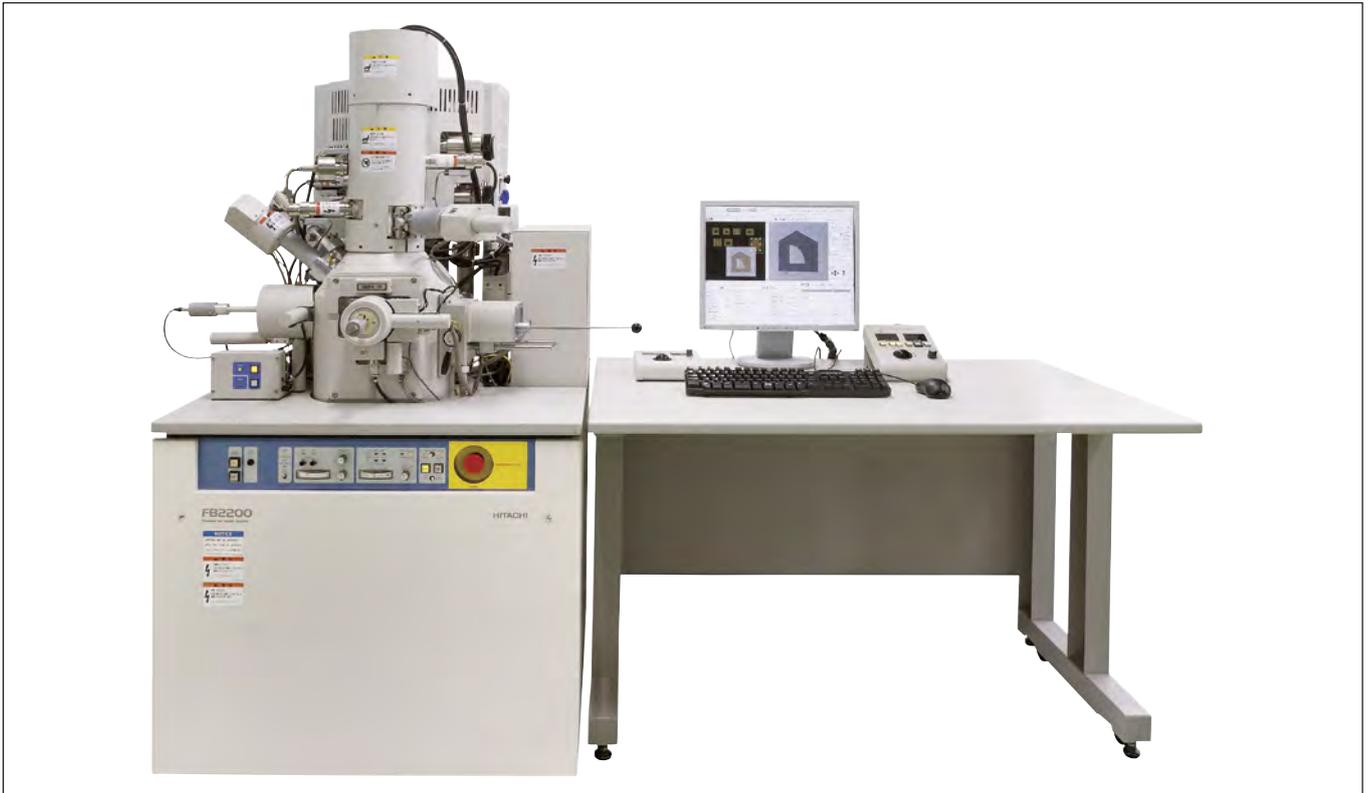
Fig. 6 External appearance of FB2200

Samples were prepared by the microsampling method using the FIB FB2200 (Hitachi High-Technologies Corporation; Fig. 6). This method involves transferring a specified part of the wafer to a raised sample-holder using a fine needle, and then carrying out the processing, while examining the image, and it therefore enables preparation of dislocation-containing samples, with very precise positioning. The sample-holder can be used with both FIB and STEM, and can be moved easily between the appropriate devices. In addition, the tip of a sample-holder has a mechanism with which the orientation of the sample can be changed throughout 360°.

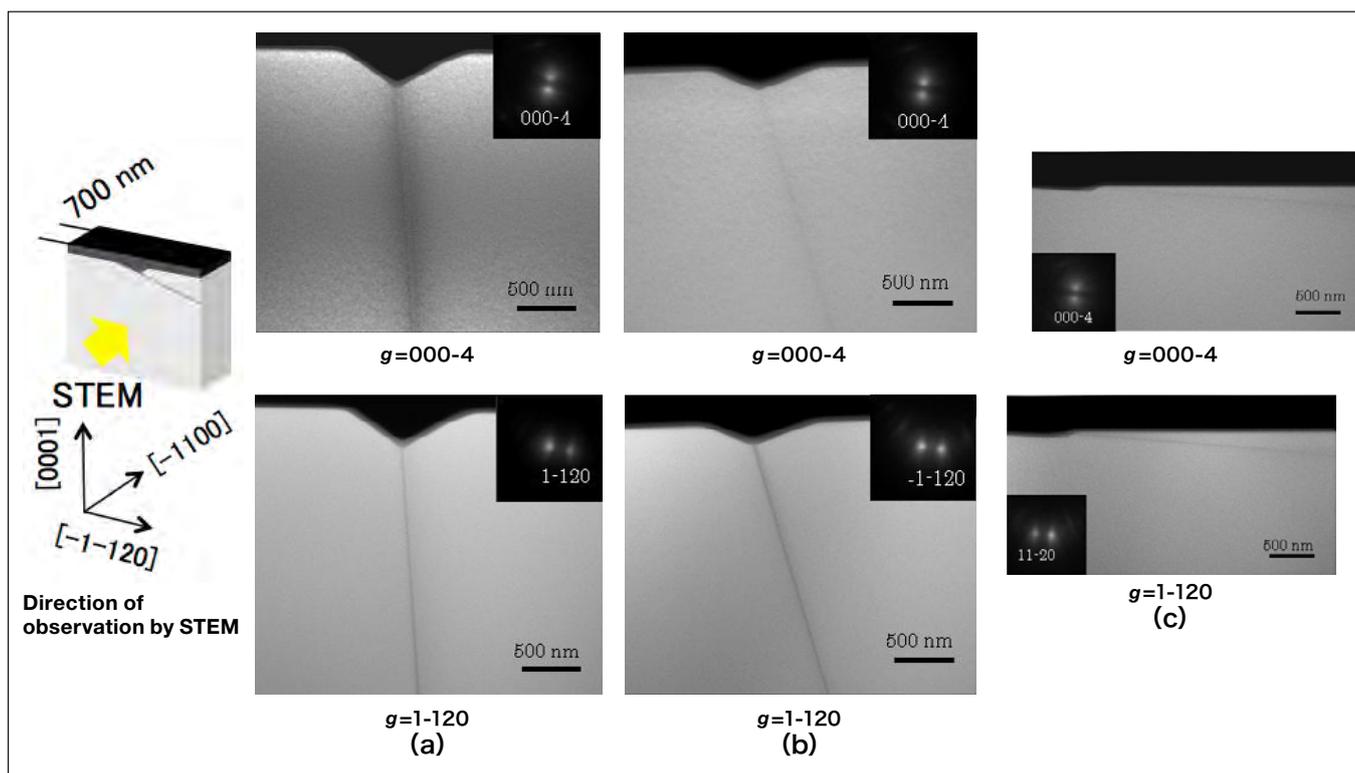
Fig. 7 Cross-sectional STEM image of core areas of etching pits
 (a) Surface defects with triangular terraces; terrace width: 270 nm
 (b) Surface defects with triangular terraces; terrace width: 90 nm
 (c) Surface defects with parallel terraces

Figure 7 shows cross-sectional STEM images of the areas of surface defects the evaluation of which is described in the previous section. The direction of observation is $[1-100]$, and the step-flow direction is from right to left, which is the opposite of that in the SEM images. Samples were prepared, each 500 nm thick, targeting the cores of each of the etching pits shown in Fig. 4. It was possible to obtain clear images of all loci, without missing any dislocations. It can be seen that the dislocations in Fig. 7 (a) and (b) are threading dislocations that are propagated in a transverse direction in relation to the wafer surface, and that Fig. 7 (c) shows a basal-plane dislocation that is propagated within the basal plane, at an angle of 4° in relation to the wafer surface. These findings were consistent with the results based on etching pit morphology detailed in the previous section. For each of the images in the figure, the orientation and excitation conditions were changed, and the orientation of the Burger's vector for the relevant dislocation can therefore be determined by comparing these. The Burger's vector is an important parameter expressing the properties of a dislocation, and it shows the orientation of distortion of the crystal surface due to the dislocation. In Fig. 7 (a), dislocations are visible with excitation at both $000-4$ and $11-20$, and it can be seen that the Burger's vector has the components $\langle 0001 \rangle$ and $\langle 11-20 \rangle$. The dislocation in Fig. 7 (b), on the other hand, is invisible and visible with excitation at $000-4$ and $11-20$, respectively, and it thus has only the $\langle 11-20 \rangle$ component, and not the $\langle 0001 \rangle$ component. In summary, the dislocation in Fig. 7 (a) is a mixed dislocation, combining components of edge and screw dislocations, whereas that in Fig. 7 (b) is an edge dislocation without any screw dislocation components. As far as can be determined from the morphologies of the etching pits in Fig. 4 (a) and (b), it is difficult to identify such differences, and STEM analysis is therefore important for detailed identification of dislocation types. On the other hand, the only Burger's vector of the basal plane dislocation in Fig. 7 (c) was $\langle 11-20 \rangle$. Two superimposed pits can be seen in Fig. 4 (c), but one remaining reason for uncertainty is that only a single dislocation line was found by STEM.

Two etching pits are seen to be superimposed, to the left side of the image. Two of the pits extend in the left-to-right direction from the cores to the dark, planar areas, and lamination defects can be seen to be present. Giving consideration to Fig. 7 (c) and 8 together, there is stacking fault aligned with the basal plane, with associated partial dislocations at both ends, and it is considered that, where partial dislocations appear on the wafer surface, two etching pits are superimposed.

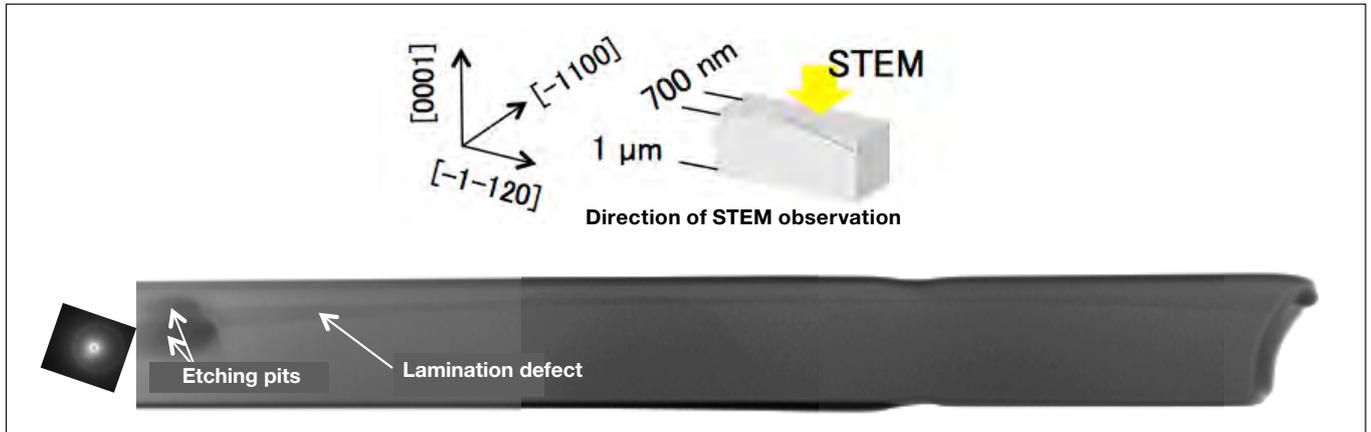
Fig. 8 Planar STEM image of the basal plane dislocation shown in Fig. 7 (c), with zone-axis incidence

In this context, examination of the sample with transmission from the upper surface was tried. Each of the sample-holders was detached from the STEM device and attached to the FIB device, after which the sample was rotated, the basal part of the sample was shaved, and a rectangular sample with a thickness of 1 μm was prepared from the epitaxial surface. The result of STEM examination of this sample from the epitaxial surface is shown in Fig. 8.
